Energy Procedia 97 (2016) 116 – 123

European Geosciences Union General Assembly 2016, EGU
Division Energy, Resources & Environment, ERE

Assessing extreme events for energy meteorology: media and scientific publications to track the events of a North Sea storm

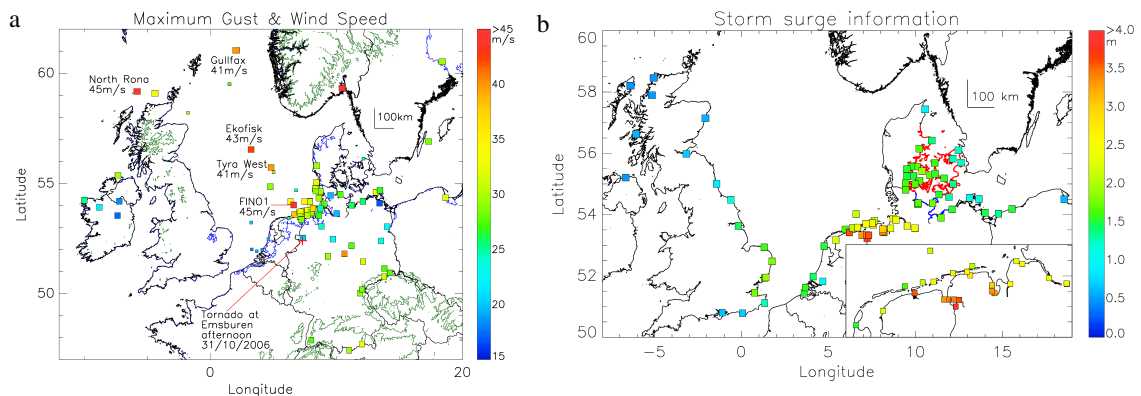
Fig. 1 (a) maximum wind gusts and (b) maximum storm surge reported during the Britta storm of Oct. 31–Nov. 1, 2006.

Onshore, high winds and gusts were prominent in the media reports and press releases associated with the storm (Fig. 1a). High winds were registered first from Ireland on Oct. 30–31, 2006 [19]. Gusts above the hurricane threshold (~ 32 m/s) were reported from Scottish islands and certain offshore platforms in the North Sea [16]. In Germany, high winds and gusts were reported from the Frisian islands and coastal areas during the predawn hours of Nov. 1 and extended southwards across the country to the Alps during the day [9,16]. In Denmark, meteorological reports note that the high wind field advanced suddenly across the country on the morning of Nov. 1 with one station registering a jump in wind speed from 3m/s to 26m/s over a time interval of only a few minutes [20].

The storm surge associated with the Britta storm was prominent in media reports especially from the Netherlands, Germany, and Denmark. Fig. 1b shows a map of the maximum sea levels that were recorded in northwest Europe. The storm surge is expressed as height above the high tide level (or skew surge) for North Sea stations or height above normal sea level for Danish and Baltic stations, which have a small tidal range. The highest storm surge was reported for the North Sea coast of Germany and the Netherlands. However, the areas impacted by the storm surge extended over a much larger area and included also the United Kingdom, Denmark, and Poland. The map has been compiled from different sources. These include online government documents and website information for the United Kingdom [21,22,23], Netherlands [11,12], and Denmark [24,25,26]. Media reports, government reports and scientific documents were used for Germany [9,14,16,27,28,29] and Poland [30,31,32]. The storm surge entered the North Sea over the top of Scotland and propagated as a coastal wave that travelled counterclockwise around the North Sea, passing the east coast of England, the Netherlands, Germany, and Denmark in sequence. Maximum sea levels occurred where the travelling storm surge wave and high tide wave coincided [33,34]. For some locations in the United Kingdom, the storm surge impacted two successive high tide levels, and many stations on the west coast of the country facing the Atlantic Ocean registered extreme minimum levels during the storm. The flooding events in eastern Denmark (Danish Inner Waters) and the southwestern Baltic Sea occurred on Nov. 1.

The damage associated with the storm surge was not directly linked with the maximum water levels shown in Fig. 1b. Different locations around the North Sea coast have different normal high tide levels, and infrastructure damage is linked to the level of the storm surge above this level. Coastal engineering structures take this into account by assessing of how often certain high water levels are expected to occur within the design lifetime of the structure: the ‘return period’ of storm surge levels [33]. For bad storm surges, media reports also describe the seriousness of a flood by reporting the last time that such an event happened in the past or by giving a series of past precedents. This

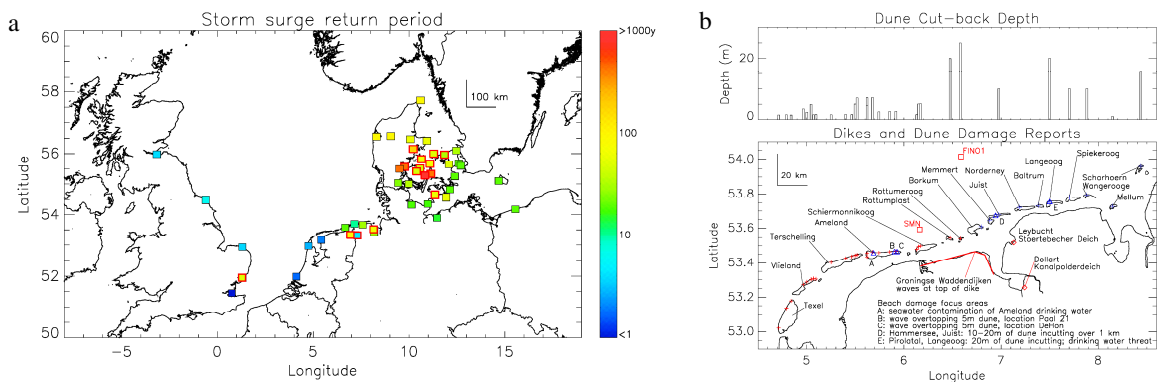
Fig. 2 (a) Previous occurrence of surge height (from press releases) or calculated return period (for Denmark) of water levels that were reached during the highest skew surge (or height over the high tide level) during the Britta storm (see text for details); (b) (top) coastal dune cut-back depths for the Frisian islands of the Netherlands and Germany and (bottom) regional map of the Frisian islands map showing dune damage focus areas (blue triangles), offshore wave recorders (red squares), and important mainland dikes (red diamonds and line).

information is used to construct approximate return periods for the surge associated with the Britta storm at the German and Polish coastal stations shown in Fig. 2a. For the United Kingdom [21,22,23] and the Netherlands [11,12], the governmental authorities presented tabulated lists of previous storm surges that were instrumentally recorded. These data permitted the calculation of average return periods, and these are also shown in Fig. 2a.

For many Danish locations in the Inner Danish Waters in the eastern part of the country, the Britta storm flooding was also an event with no precedent in the instrument records, and these are also outlined with red boxes in Fig. 2a. Here, the storm surge was particularly severe because of strong north winds were blowing southward along the Kattegat and Baltic Sea [24,34]. The following year, the Danish coastal authority published a revised report of 20-, 50-, and 100-year surge levels based on standard procedures for extrapolating extreme values in time series of limited duration [26]. The information permitted a quantification of the return period of a sea surge at the level that was encountered during the Britta storm, and these results are shown in Fig.2a. A couple of stations indicate that the Britta flood approached or exceeded the level of a 1000 year event, and this supports an assessment of the significance of the storm surge by Denmark's national insurance authority, which was made the following year [35].

There were reports of coastal damage during the Britta storm in areas close to offshore gas production platforms (Netherlands) and planned offshore wind parks (Netherlands and Germany). The coastal damage was mostly associated with the erosion of the sand dunes and cliffs that form large stretches of coastline around southern North Sea coastline of England, Netherlands, Germany, and Denmark, and also the Baltic Sea coastline of Poland. The coastal dunes form barriers to sea flooding in some areas, and also act as a natural freshwater storage on the Frisian islands of the Netherlands and Germany [36]. Reports of significant coastal damage were located for the Netherlands [11,37], Germany [38], and Denmark [39]. For the Netherlands and Germany, the beach survey reports were presented in detail, and Fig 2b (upper panel) shows this data plotted together. The figure highlights that many

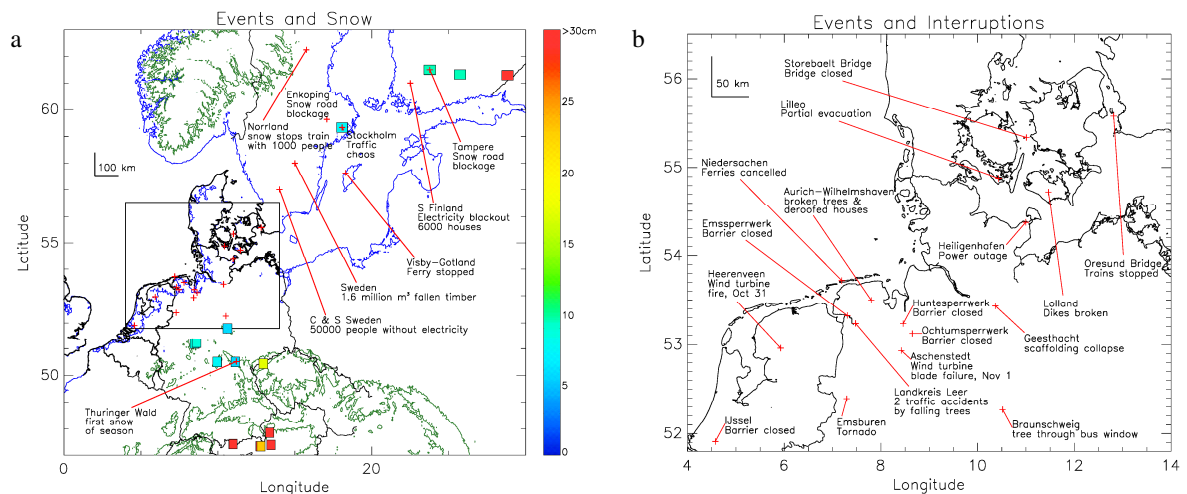
Fig. 3 (a) map of societal infrastructure impacts during the Britta storm with snow accumulations given by colour coded symbols; (b) events within the map inset box showing infrastructure impacts in the focus region of the Netherlands, northern Germany and southern Denmark.

The reported impacts on societal and energy infrastructure are presented in Fig. 3a, and Fig. 3b shows a detailed map of a focus area in northern Germany, Netherlands, and southern Denmark. Large areas of Scandinavia were affected by snow storms that interrupted transport infrastructure and caused power interruptions for tens of thousands of people mainly in Sweden and Finland [40]. The storm surge and high winds resulted in stopped ferry services for the Frisian islands, Inner Danish Waters, and Swedish island of Gotland. There were interruptions on the main bridge connecting Denmark and Sweden. The storm surge caused a power outage for the German city of Heiligenhafen on the Baltic coast, and there was flooding of harbor areas in the southern North Sea and southwestern Baltic Sea [16].

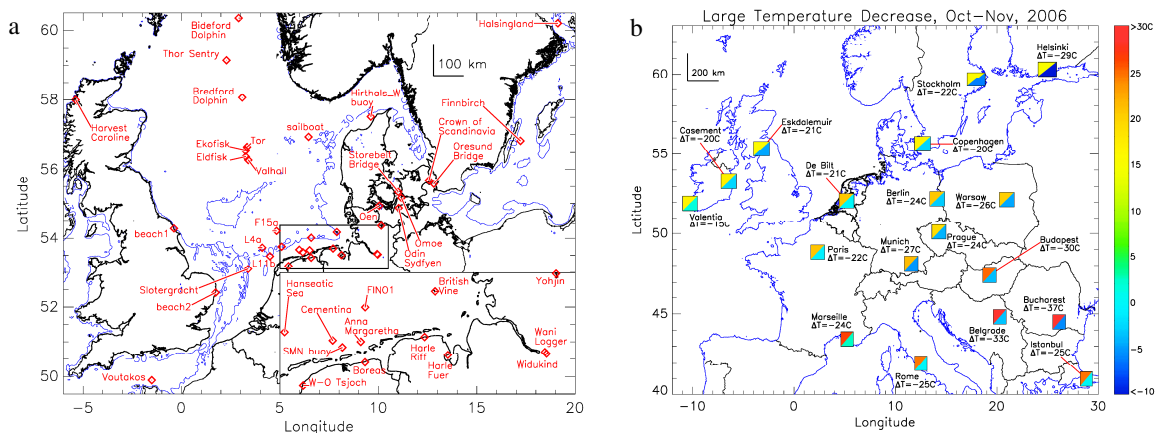
Fig. 4 (a) map of reported offshore events during the Britta storm; (b) map of maximum temperatures for October 2006 (upper left triangle of each coloured symbol) and minimum temperatures for November 2006 (lower right triangle of each coloured symbol) with the drop in temperature between the October maximum and November minimum printed beside each symbol.

The Britta storm was also important for offshore events, and these are summarized in Fig. 4a. There were a number of ships damaged or stranded in harbor and coastal events, mostly due to broken mooring lines or loss of control in high winds. There were also a number of offshore incidents where large waves broke the windows of the navigation bridge or swept away deck cargo [43]. There was a remarkable incident of a triple capsizing of a Dutch motor lifeboat in offshore breaking waves near the islands of Schiermonnikoog and Borkum while attempting to
